## Simple SSB BIAS fix

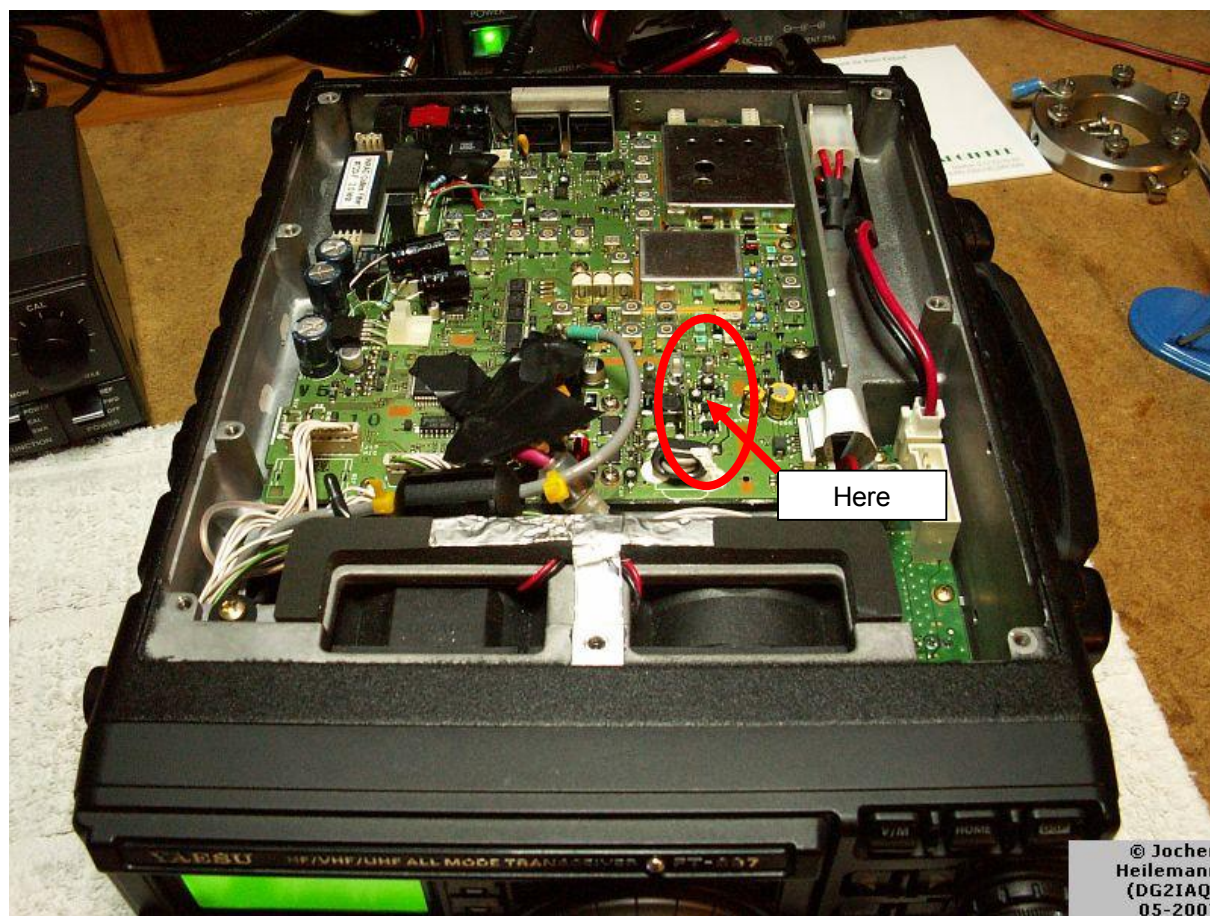
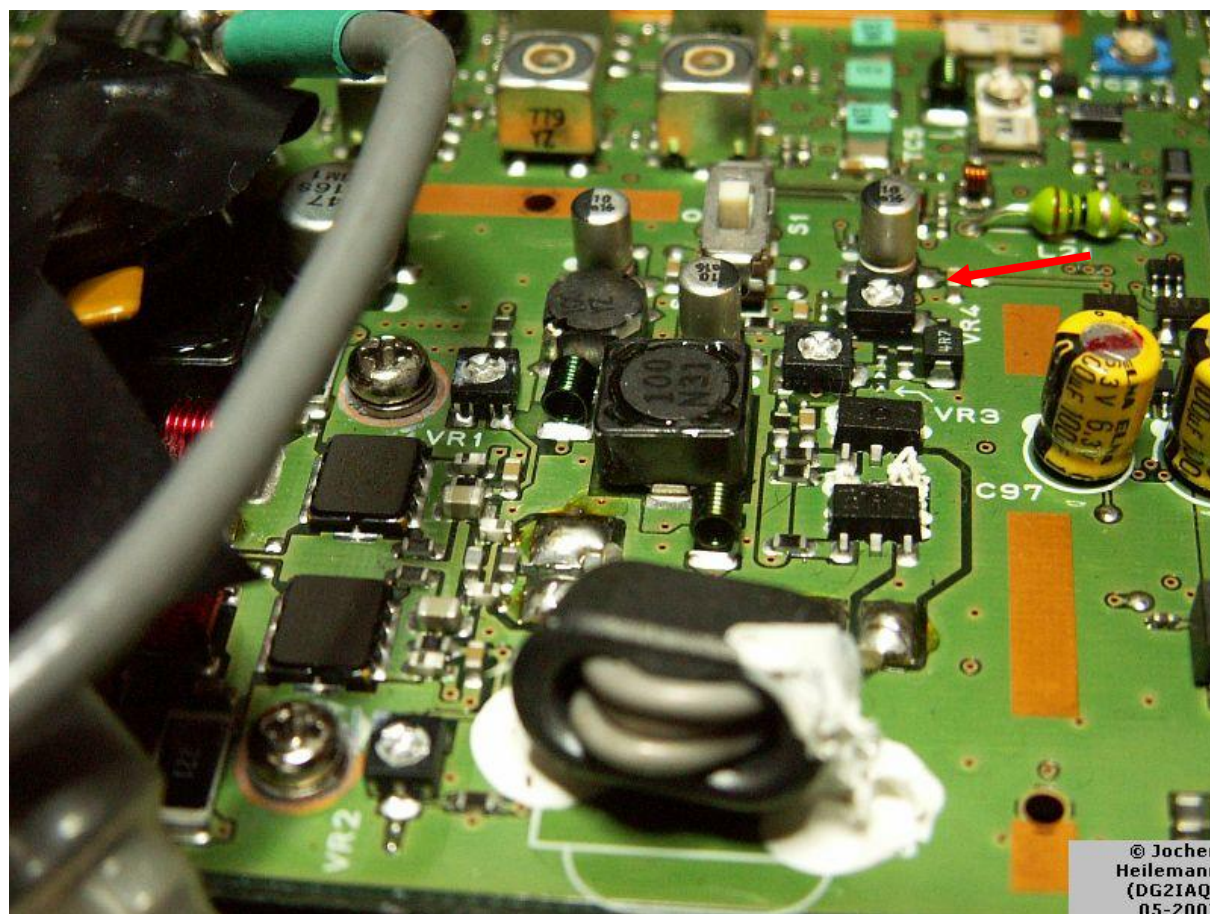
The origin "wrong BIAS problem" is that mostly only the DRIVER is set way too low (VR1003 only)

Turn them clockwise until 70%.

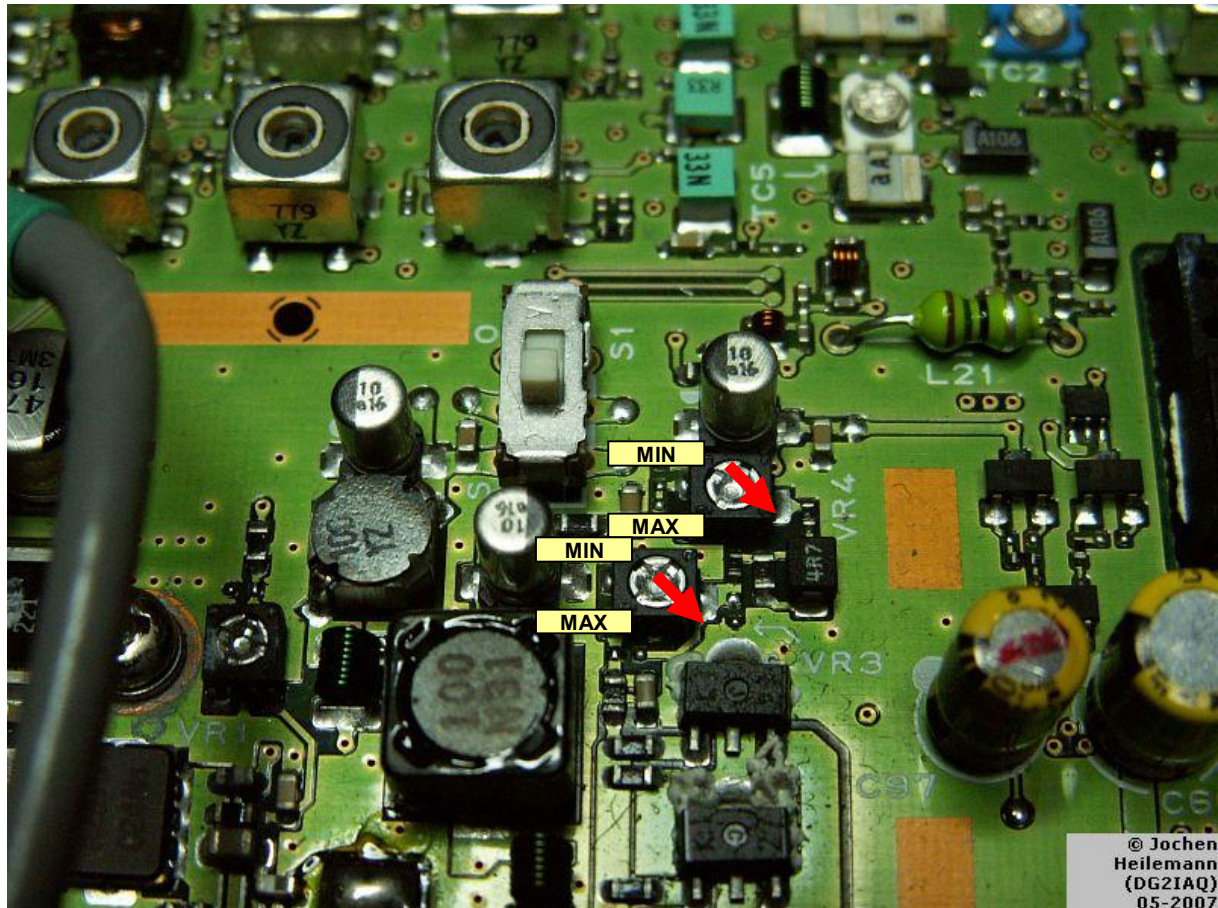
## The Fix:

Sometimes VR1004 **but for sure VR1003** are actually set to around 30% - 50%.

Turn VR4 (= VR1004) and VR3 (= VR1003) a little clockwise until they are set to the red arrow (= approx. 70%)
